## BUILDING AND MONUMENTAL STONES OF THE UNITED STATES

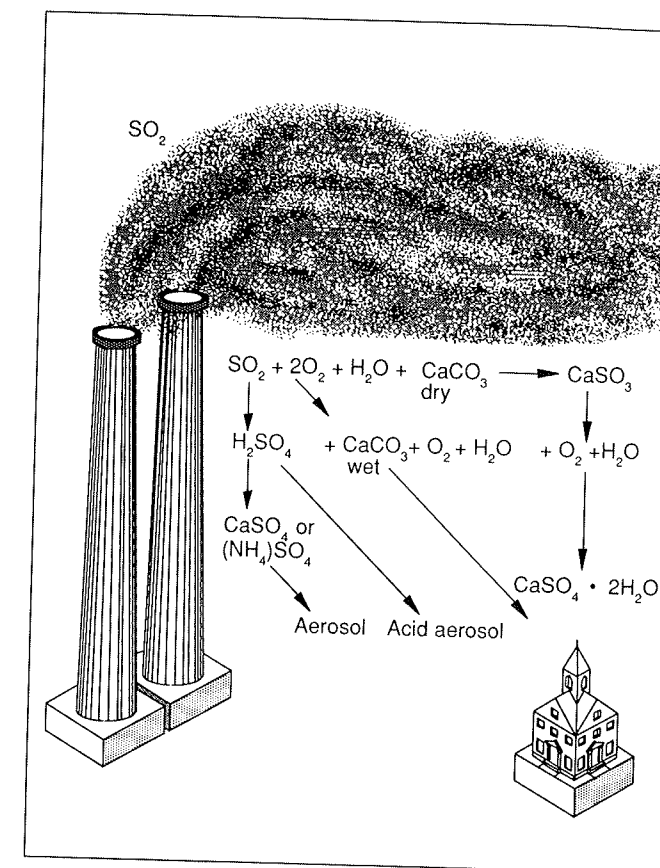
Figure 52. Air pollutants.

Acidic gases absorbed from the atmosphere by rainwater, cause it to be reactive with limestone and other calcareous stones. Sulfur dioxide, which (under typical atmospheric conditions) forms both sulfurous and sulfuric acid when dissolved in water, is perhaps the most destructive of these pollutant gases. In addition to the direct dissolution of calcium carbonate (calcite), the reaction of sulfur dioxide with limestone results in the formation of calcium sulfate dihydrate (gypsum) on the surface of the stone. As gypsum is more soluble in water than is calcium carbonate, the exposed surface becomes eroded when washed by the rain. Where this

surface is protected from the flow of rainwater, the continued transformation of calcium carbonate into calcium sulfate dihydrate results in the formation of a "crust" of gypsum. Particulate matter becomes entrapped in the network of gypsum crystals, giving the surface of protected areas a blackened appearance.
