# The Brownstone Guide

Maintenance & Repair Facts  
for Historic Property Owners

**New York Landmarks Conservancy  
Technical Services Center**

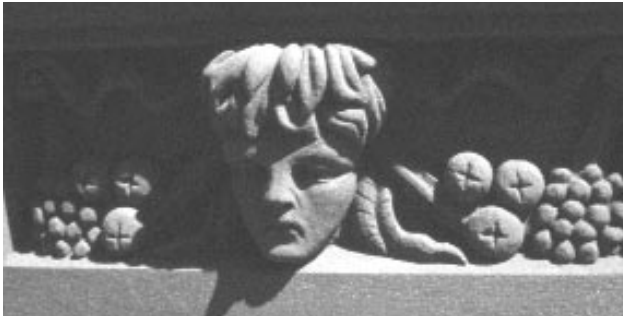
*The relative softness of brownstone lends itself to decorative carvings and building ornamentation.*

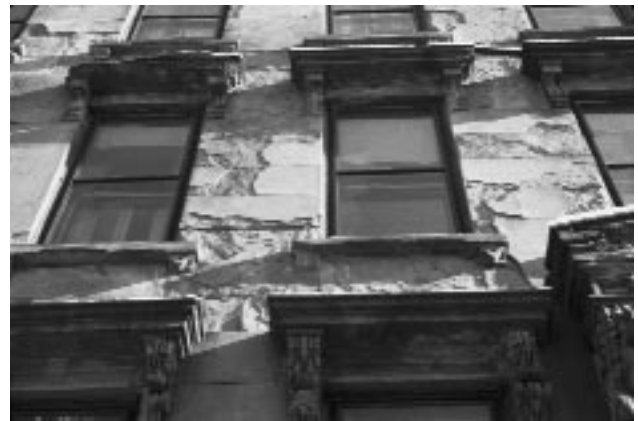
*Severely exfoliating brownstone can be both unattractive and detrimental to the building.*

**Exfoliation:** Separation and failure of stone along its sedimentary bedding planes. Exfoliation causes the most dramatic failure when a stone unit is "face-bedded," with its bedding planes set parallel to the finished face of the stone. "Blind exfoliation" describes bedding layers that have separated but are still loosely attached, causing the finished surface to sound hollow. Exfoliation is caused by the failure of weakly cemented layers in a stone unit.

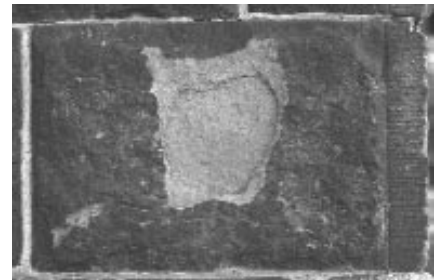
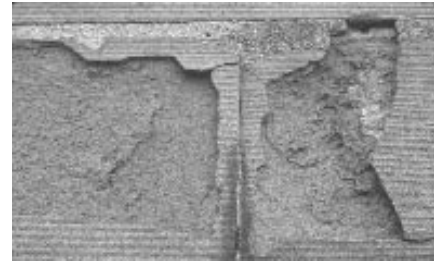
*Contour scaling (top) and disaggregation (bottom) are two commonly found forms of brownstone deterioration.*

**Contour scaling:** Failure of a thin surface layer of the stone parallel to the worked surface of the stone, rather than along its bedding planes. “Crust formation,” “blistering,” and “surface induration” are terms used for similar deterioration. Contour scaling occurs when acid-soluble binders dissolve and form a brittle crust at the surface of the stone. This is most likely to occur in areas of frequent wet-dry cycling, such as windowsills and copings.

**Disaggregation:** Loss of cohesion between sand grains as the binder deteriorates. Disaggregation at the surface of a stone can result in slow erosion of the surface and softening of tooling. Areas beneath surface crusts are also often disaggregated. Disaggregation often occurs in sheltered areas where moisture from other sources evaporates, in some cases from salt recrystallization.

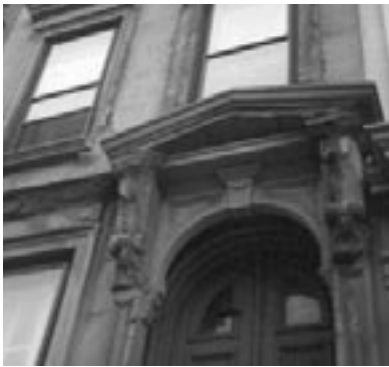
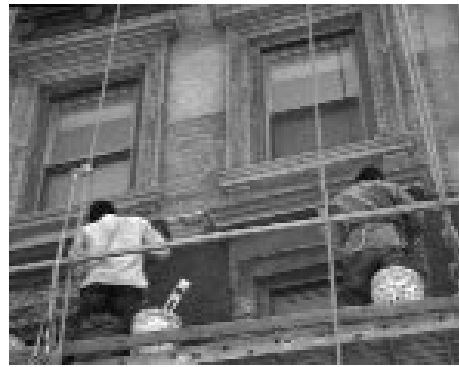
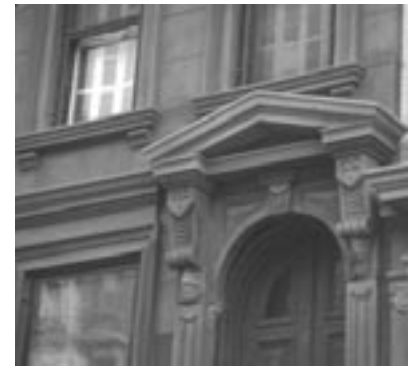
*Years of weathering caused the brownstone details to deteriorate (left), but careful composite repairs (center) restore it to its original glory (right)*

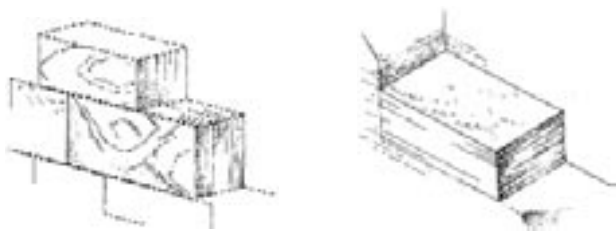
*Brownstone can be laid with its natural bedding planes oriented vertically, called face bedding (left), or horizontally, called quarry bedding (right).*

**NATURAL STONE** For simply tooled units of wall masonry, natural stone is often the most appropriate choice. Generally natural stone will be more expensive, but is usually a better match for surrounding masonry. Finding a stone that matches the color of the original stone is extremely important. Salvaged stone, taken from buildings that have been demolished, is often available and the simplest choice for smaller projects. For new brownstone, quarries are currently active in Connecticut, Michigan, and Canada’s maritime provinces. For larger projects, imported stone resembling some brownstone in the Northeast is available through American suppliers from Germany, Scotland, and England. Whenever possible, brownstone should be laid with its natural bedding planes oriented horizontally (“quarry-bedded”).

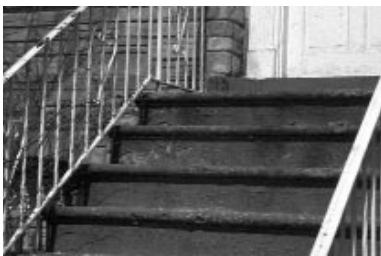
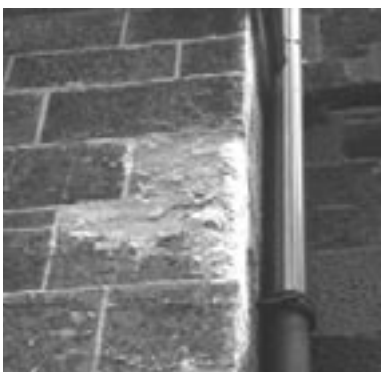
*Inappropriate repair methods, such as painting (top) and cementitious coatings (bottom), tend to trap moisture and mask underlying brownstone deterioration.*

**Cementitious Coatings** Tinted cementitious coatings are available under a variety of trade names and are one of the most common repair methods to avoid. Unlike composite repairs, which are generally applied only to deteriorated stone, brush-on cementitious coatings are often indiscriminately applied to entire façades of sound and deteriorated stone. These coatings tend to hinder vapor transmission through the stone surface and hold water inside the stone, eventually causing it to disaggregate. In areas of severe water infiltration, near roofs or parapets, coatings such as these may lead to frost damage. While they may match stone coloration when they are initially applied, cementitious coatings tend to fade and may be highly disfiguring. They are also difficult to remove without damaging the surface of the stone.

**Painting** Painting brownstone is generally not recommended. Even paints that are vapor permeable may retard the passage of moisture and cause the underlying stone to deteriorate. This is especially true where cracks or open joints allow water to enter the masonry. A thick paint buildup may lead to future damage by trapping moisture in the stone behind it. Painting will not preserve decayed stone, since paint will adhere only to sound material.
