CHAPTER 5

RESTORING STONEWORK

RESEARCH

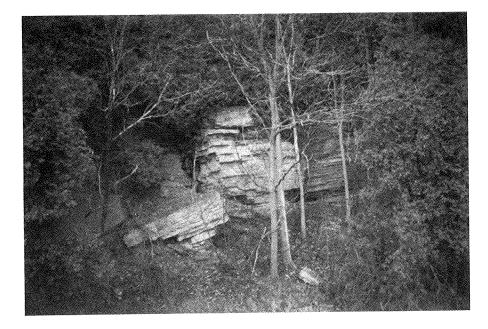
Small quarry close to 19th century Ontario house.

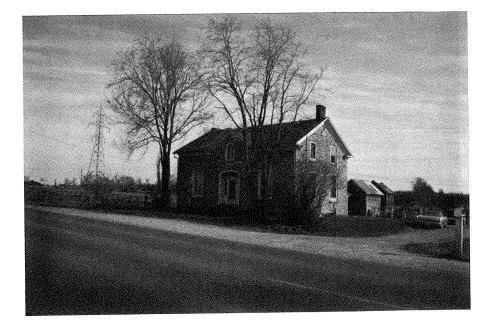
House built from very local stone.

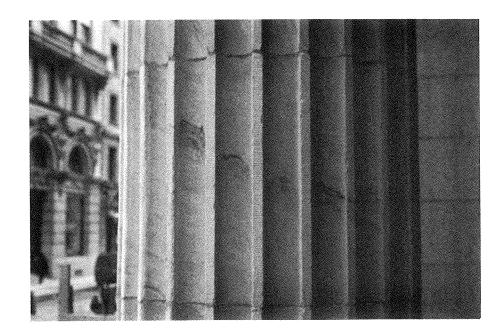
Acid soluble stone; note the damage to left face which was exposed to the rain.

Are the Stones Wholly or Partly Water Soluble? For example, alabaster or crystalline calcium sulfate is partially water soluble. Are the stones wholly or partly acid soluble? Carbonate rocks such as limestone and marble are soluble in acids. Do the stones show any signs of having been partially dissolved? Stones which are partially soluble in water and acids such as acid rain will often hold up remarkably well until an open mortar joint, an eavestrough, or a rainwater pipe leaks into the masonry on a prolonged basis. Then the stones may be totally destroyed. In such situations, remedying leaks and carrying out limited repairs to mortar and some stones may greatly extend the life of the stone masonry.

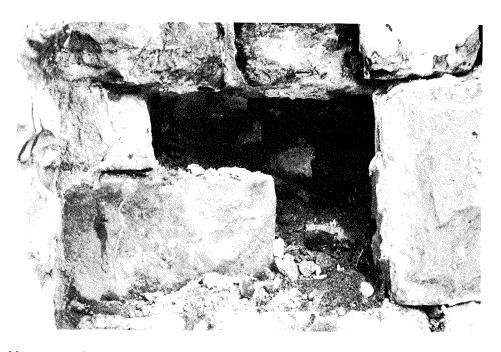
Mortar turned to sand by prolonged penetration of acid rain, St. Mary's Cathedral, Kingston, Ontario.

What are the Nature and Condition of the Mortar in Which the Stones Were Laid? Earlier mortars tend to be based on lime rather than hydraulic cements. Lime mortars are acid soluble and tend to be very badly damaged by acidic rainwater and snow melt water if leaks and cracks are left unattended for years. Ultimately the lime is removed and only wet sand remains. The deposition of sheets of redeposited carbonates on external surfaces of walls and on the soffits of arches are sure indicators that lime is being removed from within the wall and that the wall is being seriously weakened in the process.

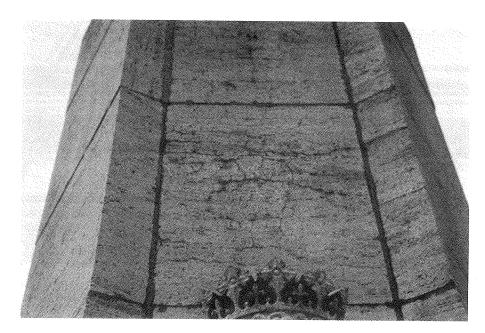
A major structural crack passes through a block of limestone at an angle. Close inspection of the limestone blocks also reveals networks of microcracks which are being penetrated by acid rain. Ultimately these will cause the blocks to fall apart.
